**LOWER HOUSATONIC RIVER BASIN
SEYMOUR, CONNECTICUT**

**GREAT HILL RESERVOIR DAM
CT 00087**

**PHASE I INSPECTION REPORT
NATIONAL DAM INSPECTION PROGRAM**

AUGUST 1978

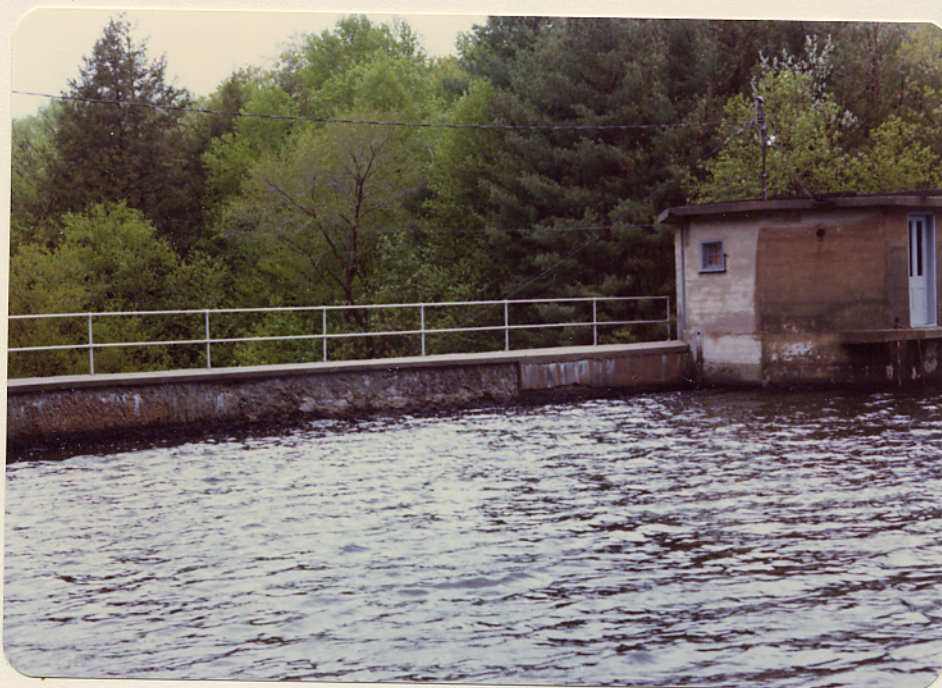
PHOTO NO.1 - Spalling at upstream face of left abutment.

1. Repair of spalled areas along entire length of dam including the crest and up and downstream faces; while establishing a regular maintenance program to resurface reoccurring spalled areas of the dam.
2. Inspection of the dam at least once every 2 years by an inspector qualified in dam inspection.
3. Opening of the low level outlet valve twice a year for a minimum of 6 hours. This would assure that it is operable and that the inlet doesn't clog with sediment.
4. Round the clock surveillance should be provided by the owner during periods of unusually heavy precipitation. The owner should develop a formal system with local officials for warning downstream residents in case of an emergency.

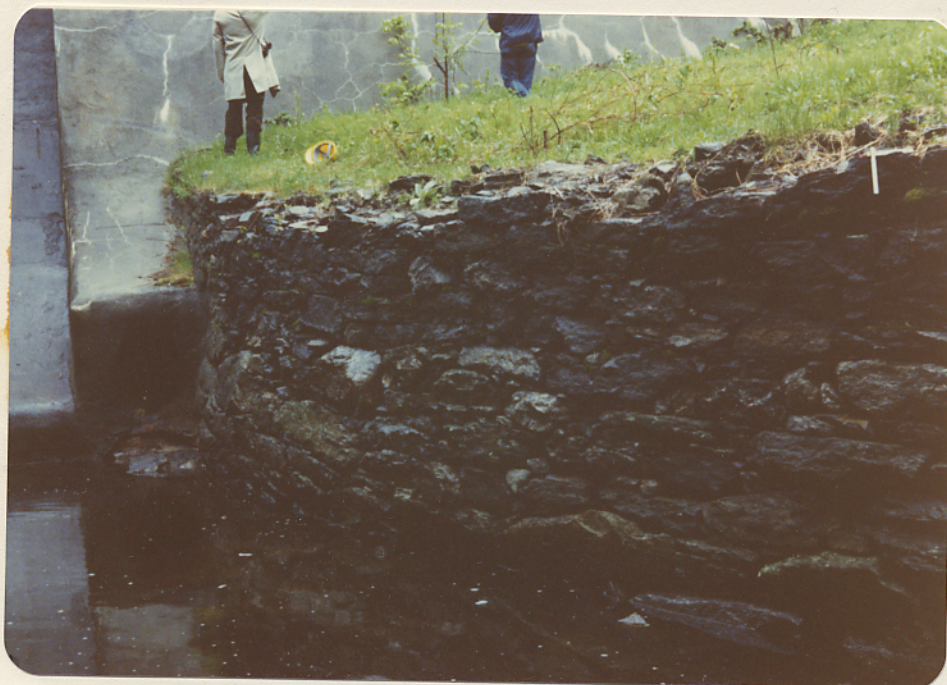
c. Appurtenant Structures - The channel immediately downstream of the dam has stone retaining walls on both left and right banks. The walls are in good condition, except at the downstream end of both walls where a short section of the walls have collapsed.

PHOTO NO.2 - Spillway channel, left retaining wall.

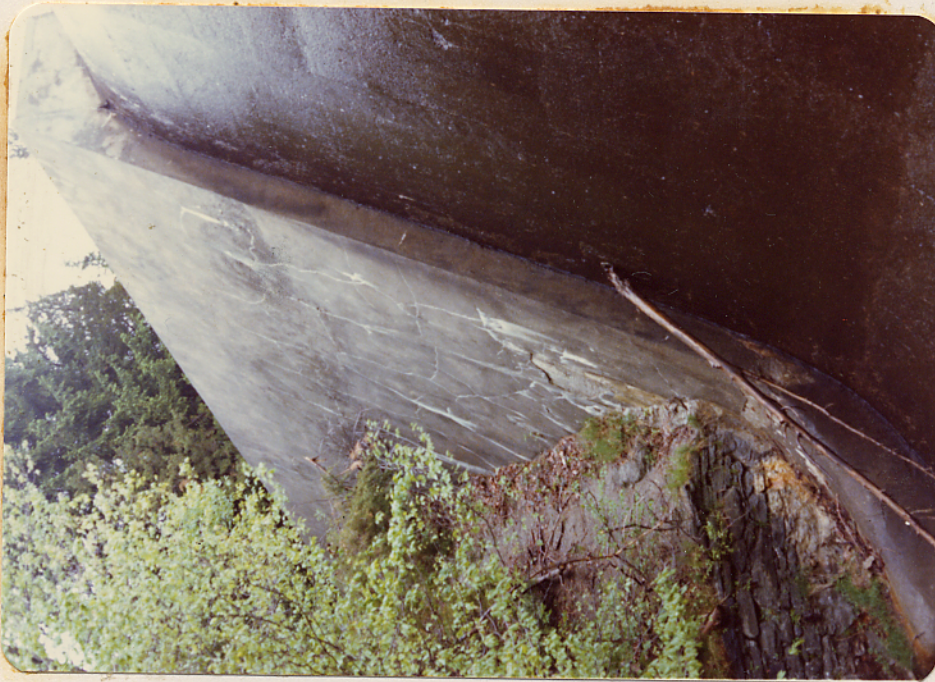
PHOTO NO.3 - Cracking of parged surface
of downstream right abutment.

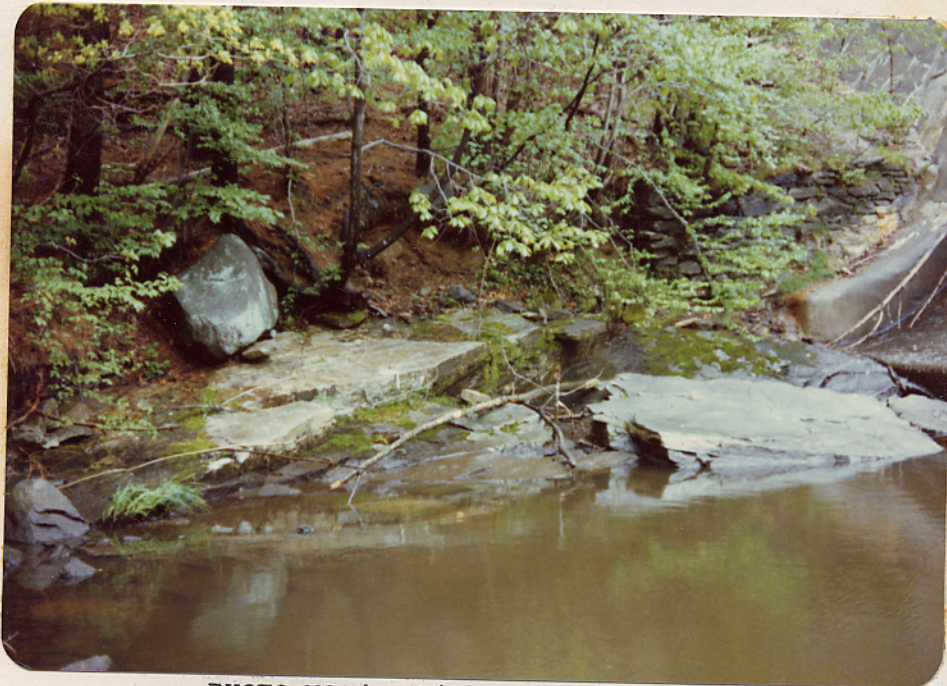
There were no seeps observed at the base of the dam. At the base of the right abutment, a small seep of clear water was observed through the exposed bedrock joints about 20 ft. downstream of the dam.

PHOTO NO.4 - Right abutment, immediately
downstream of dam. Note
exposed bedrock.

2. Provide capability for passing the Test Flood without causing dam failure or significant downstream damage.
3. Implement surface improvements which may be required at the abutments of the dam to minimize erosion caused by water flowing over the dam.
